Fire in the Heinenoordtunnel, Lessons learned.

René de Feijter¹, Remco van Werkhoven², Mark Goudzwaard³ & Ron Beij⁴

¹Efectis Netherlands BV, Bleiswijk, The Netherlands

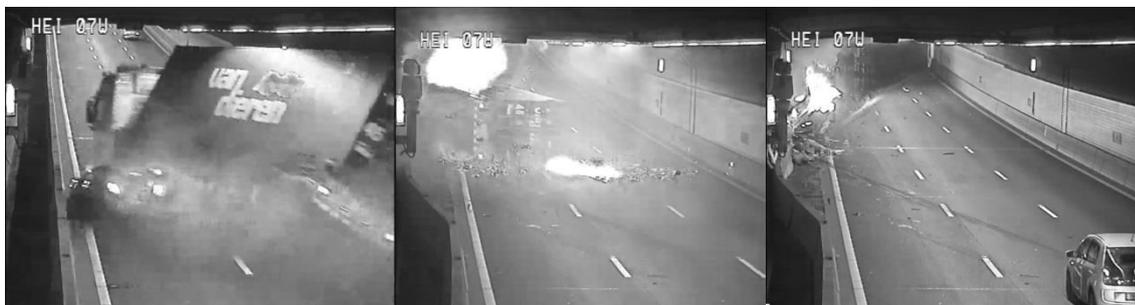
Figure 4 Crash and start of the fire.

At 13:30:51 on May 21th the Fire department was alarmed for a fire in the tunnel. According to an eye witness on Youtube (and the camera footage), a tyre of the truck (a Mercedes-Benz Actros 1841 LS) involved in the accident blew up. The truck drove into the concrete barrier and the tunnel wall on the left side. After hitting the wall the truck turned over and immediately caught fire. In the crash the truck hit another car (Ford Fiësta, 2013). The truck slid while burning over approximately 100 meters through the tunnel and stopped, blocking 2,5 lanes of the tunnel. The car that was hit by the truck turned upside down right behind the truck. The driver and passenger of the car got out on their own with severe (burn) injuries. The truck driver died in the accident.

The camera footage shows that the fire grew quickly (within one minute) directly after the crash. This rapid fire development can only be explained by a ruptured fuel tank. The hypothesis of a ruptured fuel tank is confirmed by the fact that just after the crash a reflecting surface (pool of diesel fuel) is visible between the truck and the car behind the truck.

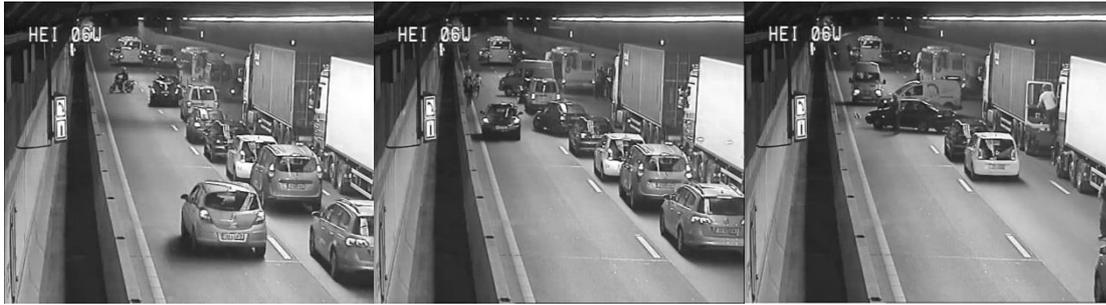
Figure 5 Evacuation.

The camera images show people backing up and turning their cars (Figure 5). One person parked his car across the third lane and leaves it there.

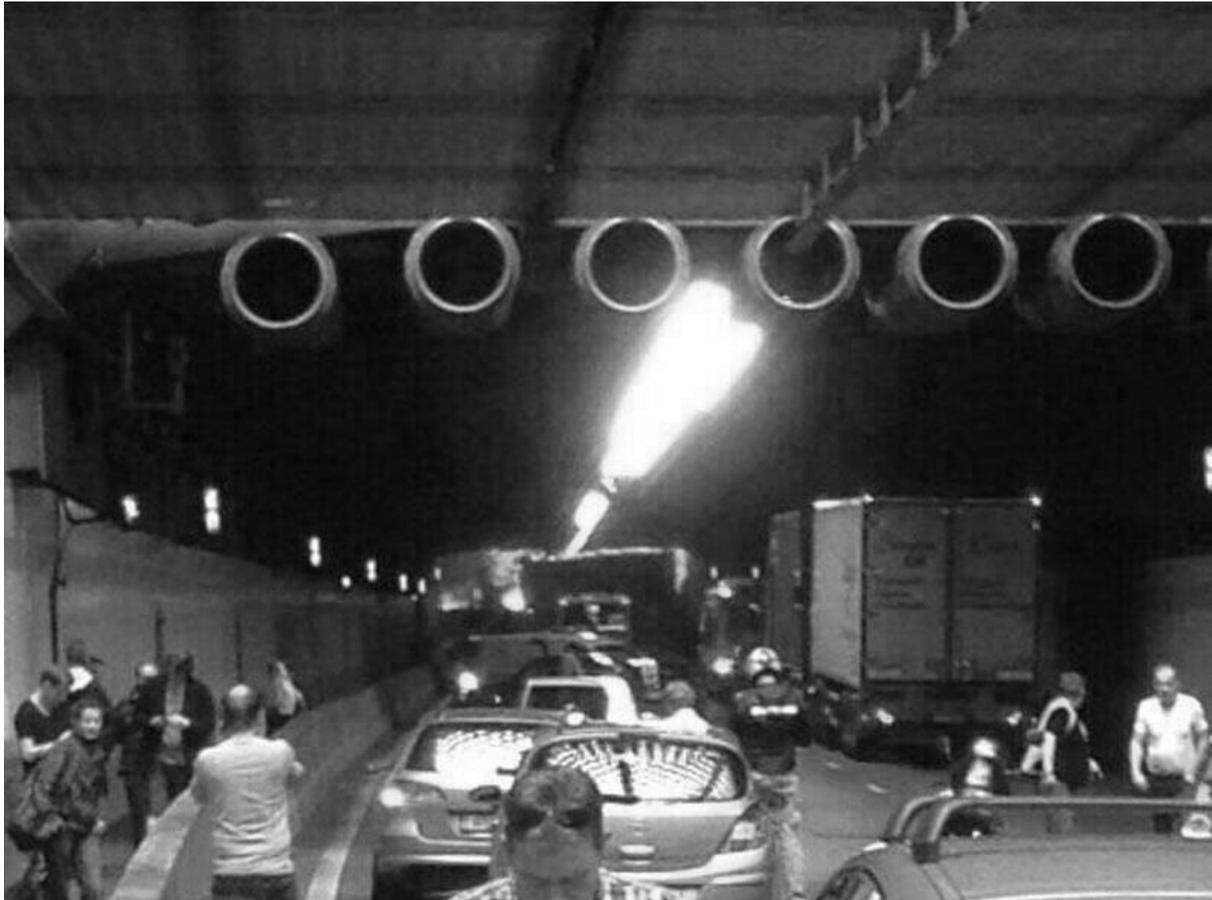
Figure 6 Picture taken from the tunnel entrance. The cross section of the tunnel just behind the truck is engulfed in flames (source: Twitter @RichardMaasdijk).

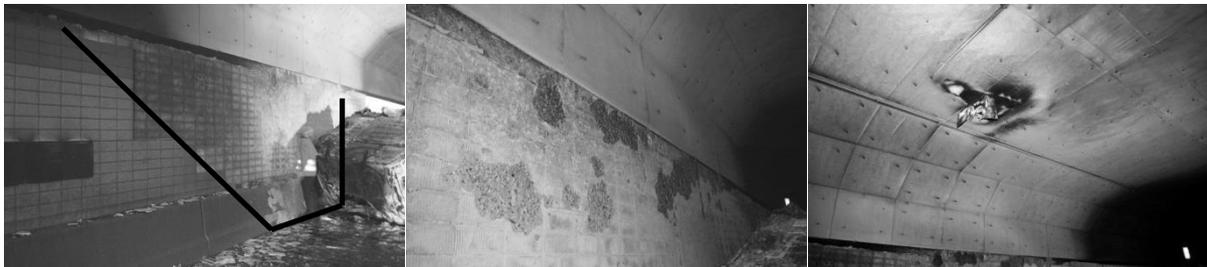
Figure 7 Damage to the tunnel wall and ceiling.

The tunnel roof and the upper parts of the walls are protected with a 27,5 mm thick PROMATECT-H lining. The lining is mounted in 1990. The damage patterns on the wall next to the truck cabin indicate the influence of longitudinal ventilation. Figure 7 gives an impression of the damage pattern on the tunnel wall. The damage extends in the direction of the airflow. The lines in Figure 7 give an indication of the shape of the damage.

In the direct vicinity of the truck cabin the concrete wall showed damage due to spalling. A maximum spalling depth of 2,5 cm was measured. The concrete showed a buff discolouration, which indicates temperatures reached more than 1.000 °C [9]. The discolouration of the concrete was only visible around the cabin and can be explained by direct flame impingement.

From within the tunnel the PROMATECT-H lining showed no visible damage. After editing the photo used in Figure 7 it became visible that some parts of the tunnel lining were cracked. It is not possible to determine whether these cracks are a result of the fire or were present in the lining before the fire occurred.

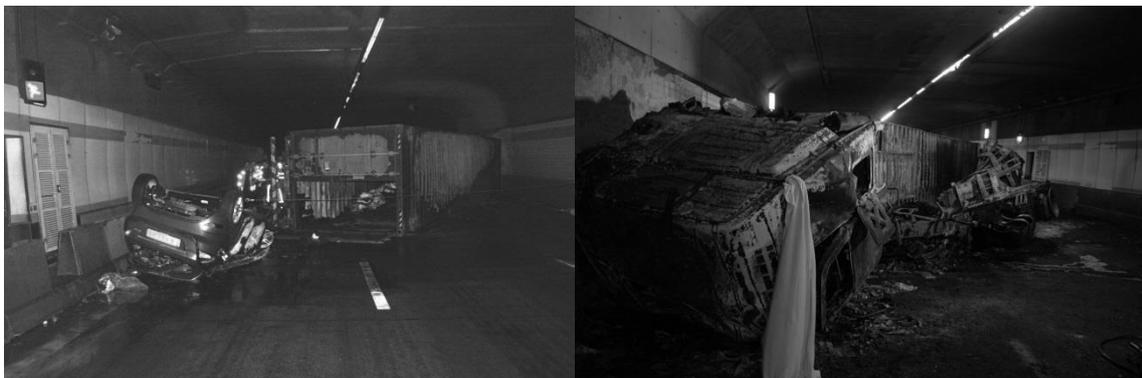
Figure 8 The damaged lighting system still functions.

Under the tunnel ceiling a lighting system was installed consisting of LED lights. Most part of this lighting system was still working after the fire. Some parts were melted or soothed. In Figure 8 the damage to the lighting system is visible in an overview of the accident area in the tunnel.

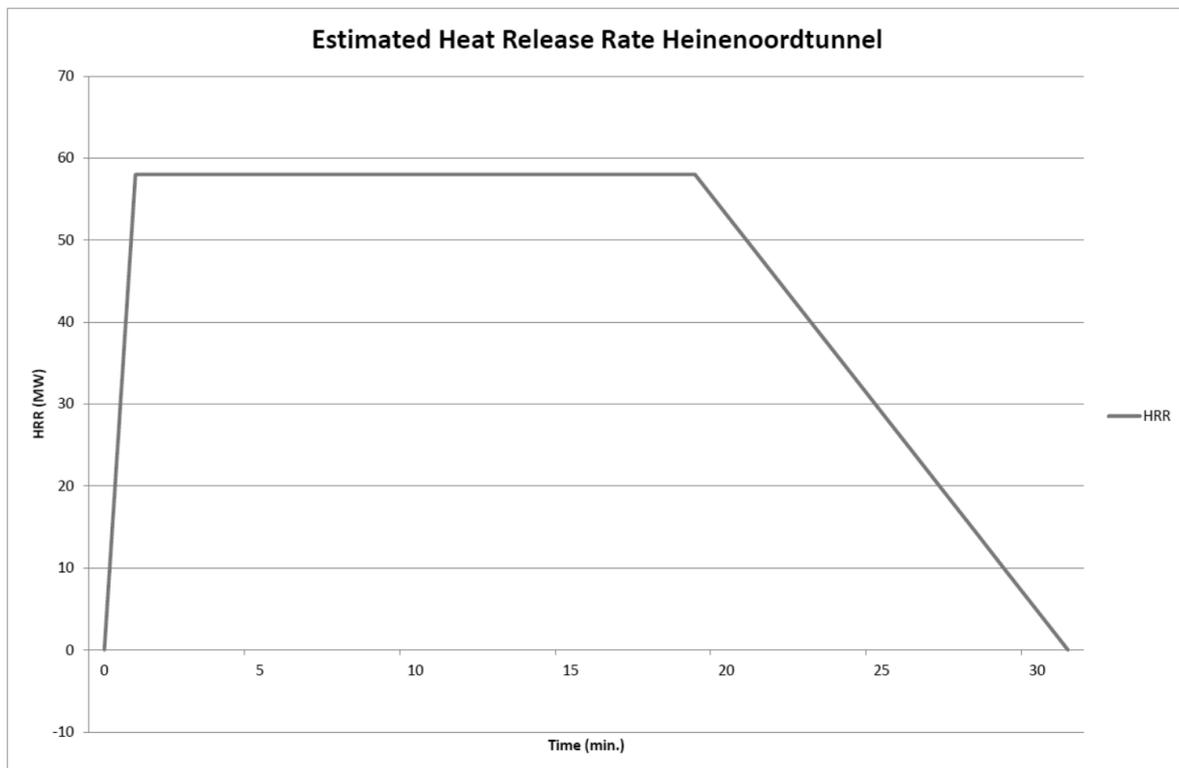
Figure 12 Estimated fire curve.

The analysis of camera footage leads to a fire curve that grows to a maximum in 1 minute and maintains about the same rate of heat release (HRR) during 18 minutes. The fire lasted for a total of 31 minutes.

The peak output of the fire is estimated to be between 50 and 65 MW. In Figure 9 the estimated fire curve is given. The fire curve given in figure 9 is a simplified curve because there is only limited data on the development of the fire.
