Tunnel Fire in Heinenoord Road Tunnel, The Netherlands: Safety Installations Response and Human Behaviour

On 21 May 2014, an accident occurred in the Heinenoord Road Tunnel resulting in a fire of approx. 50 MW. The tunnel surveillance cameras recorded the event, which has made it possible to analyse not only the accident itself but also the events following the accident. This article describes these events and analyses the behaviour of the people present in the tunnel at the time of the accident, the actions taken by the tunnel operator and the response of the tunnel safety installations. Based on the analysis, lessons are drawn regarding human behaviour during evacuation and the role and the effectiveness of the tunnel installations.

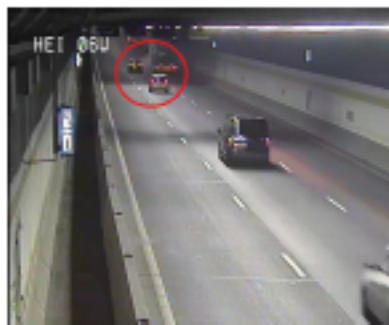
Figure 1 Tyre collapse

The accident was caused by a tyre collapse (Figure 1) resulting in a driver losing control of his truck. Due to the loss of control, the truck hit the barrier and the tunnel wall and burst into flames almost immediately (Figure 2). The truck was carrying 20 t of salt (KCl) and a considerable amount of fuel (diesel). As can be seen in Figure 2, a car with two people inside was caught up in the accident. The two people in the car were able to rescue themselves, but unfortunately the truck driver lost his life.

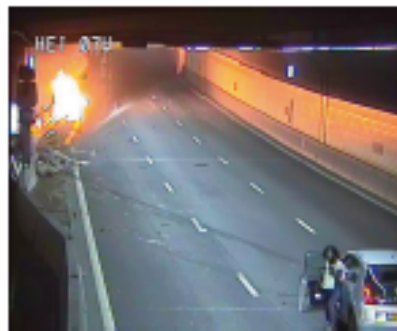
Figure 5 Passenger of car closest to accident flees

The car closest to the accident stops after a distance of approx. 18 m. After only 5 sec, the driver opens the door of the car and is gone after 19 sec. The driver obviously is aware of the danger and has little doubt what to do; the car is left behind, some personal belongings are taken and the driver flees (Figure 5).

The person closest to the accident (approx. 18 m) takes very little time to assess the situation as dangerous (5 sec), makes a quick decision to flee and is gone after 19 sec.

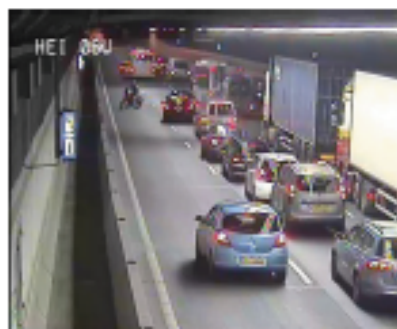
Figure 6 Motorcyclist in doubt

- A motorcyclist close to the accident is in doubt what to do. He rides closer to the accident, turns several times but finally decides to leave the tunnel on his motorcycle after almost 2 min (Figure 6).

Other drivers, who have stopped inside the tunnel and also at a relatively close distance from the accident (approx. 30 m), have a good view of the situation and are in doubt. One curiosity is that the motorcyclist is clearly in doubt whether to help, leave the tunnel or instruct people. It is almost 2 min before the motorcyclist leaves the tunnel on his bike. Several drivers are reluctant to leave their cars and try to get away from the accident by reversing or turning their cars.

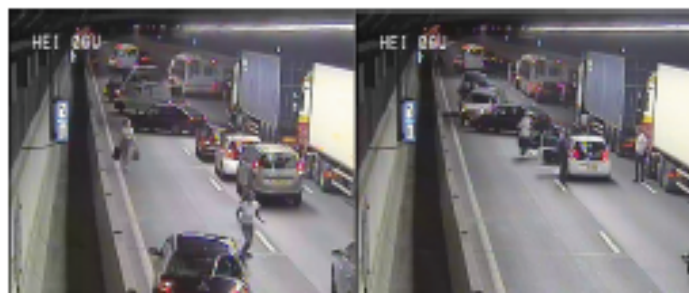
Figure 7 Cars trying to reverse, people fleeing and drivers in doubt

- Close to the accident, two busses and several trucks are present. After 30 sec, the first people from the busses are seen to evacuate. After approx. 40 sec, the first cars start trying to reverse, which they do while people are already fleeing by foot to the tunnel portal using the traffic lanes. At first, nobody uses the evacuation route provided behind the barrier although the moving cars are creating an unsafe situation. Only when they come closer to the tunnel portal do some of them start to use the evacuation route behind the barrier. After approx. 1 min, cars are still trying to reverse and after 1.5 min people still seem to be in doubt what to do with their cars. They are reluctant to leave their car inside the tunnel or close to the accident.

- The truck is burning but thanks to the forced ventilation, no smoke and very little heat – only heat due to radiation – is present upstream of the accident. People seem to be unaware of the potentially dangerous situation caused by the fire. On the videos, it can be seen that truck drivers have to urge people in cars to leave their cars behind and evacuate the tunnel (Figure 7).

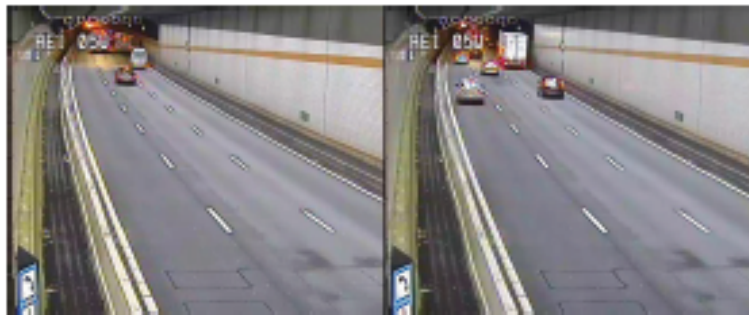
Figure 8 Tunnel portal at $t = 0$ sec (accident) and $t = 15$ sec when traffic stops

At the time of the accident, the number of vehicles using the tunnel was moderate compared to rush hour. The traffic flow comes to a stop at the portal after approx. 15 sec (Figure 8).

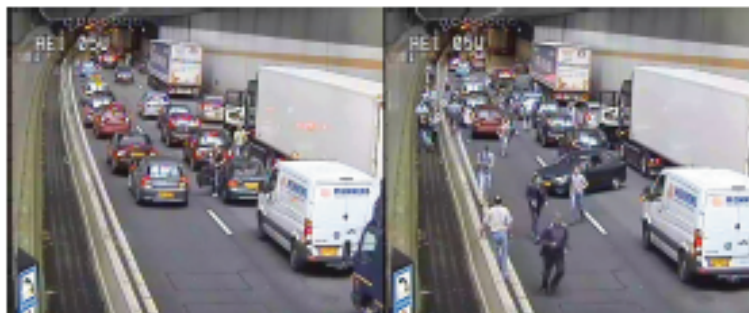
Figure 9 People arriving from the accident at the tunnel portal

Already after 40 sec, the first vehicles try to reverse and after 1 min and 40 sec the first people who were inside the tunnel at the location of the accident arrive at the tunnel portal, some of them now using the evacuation route behind the barrier (Figure 9).

- After 1 min and 40 sec, the first people who were inside the tunnel close to the accident reach the tunnel portal. They have covered a distance of approx. 300 m.
