Fire behaviour of large scale loaded tunnel segment tests for project Rotterdamsebaan, the Netherlands

Kamakshi Parwani, Jos Bienefelt, Tomas Rakovec

Efectis Nederland B.V., the Netherlands

Project team Rotterdamsebaan, Municipality of The Hague, the Netherlands

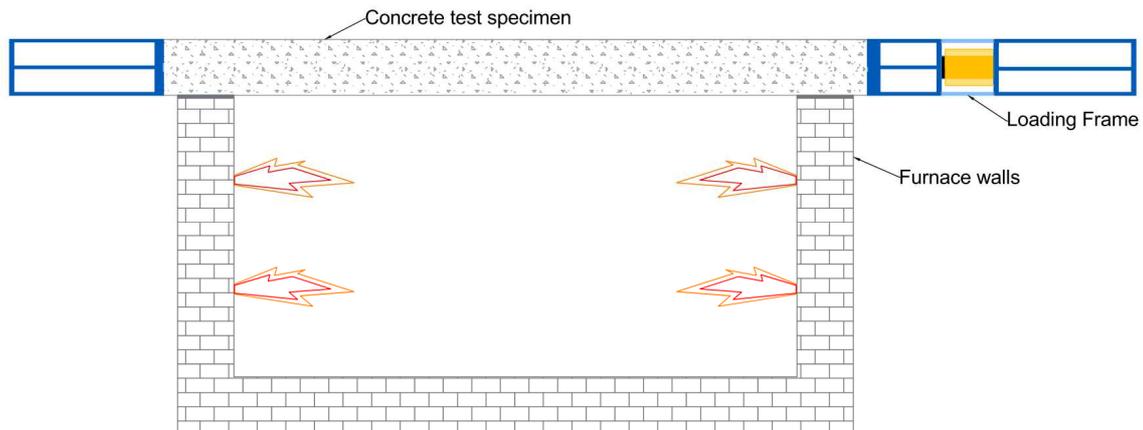
Figure 2 . Scheme of the experimental setup

As already explained in the previous chapter, it is important to test a scenario that as closely as possible reflects the situation on-site. The test specimens are placed horizontally on the furnace. The exposed surface of the specimen is 4 m x 2.4 m. The specimen was supported on two sides and had two free edges. In Figure 2, the scheme is shown, the test specimen is loaded horizontally with the loading frame. The loading frame is described in Figure 3 and an overview of the resulting compressive stress in the concrete slab (on the exposed surface) is given in Table 2. The weight of the concrete test specimen is ignored while calculating the load to be applied laterally. It

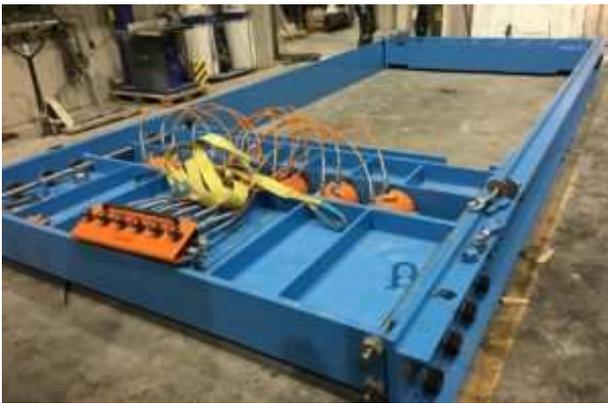
Figure 3. Loading frame

The slabs were cast and thereafter cured for a period of minimum three months. The required compressive stress in the concrete slab was applied using the Efectis loading frame. The test specimens are subjected to RWS tunnel fire curve for a period of 120 minutes.

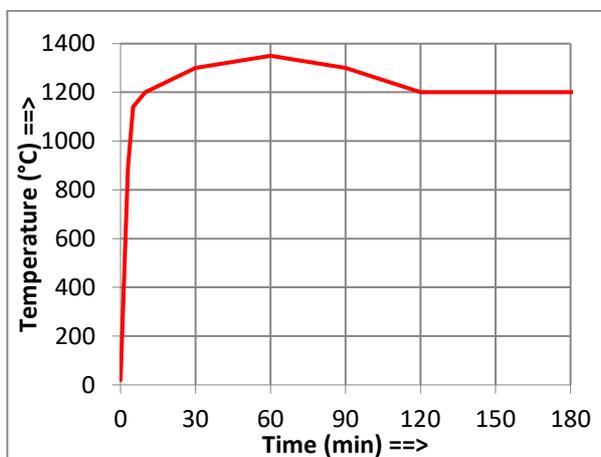
Figure 4. RWS fire curve

The RWS fire curve, as shown in Figure 4, was used for all the fire tests. The temperatures in the furnace are measured with special temperature sensors, in this case mineral insulated sheathed thermocouples. The furnace pressure is maintained at a positive pressure difference of around 20 pascal with respect to the ambient pressure for all the fire tests.

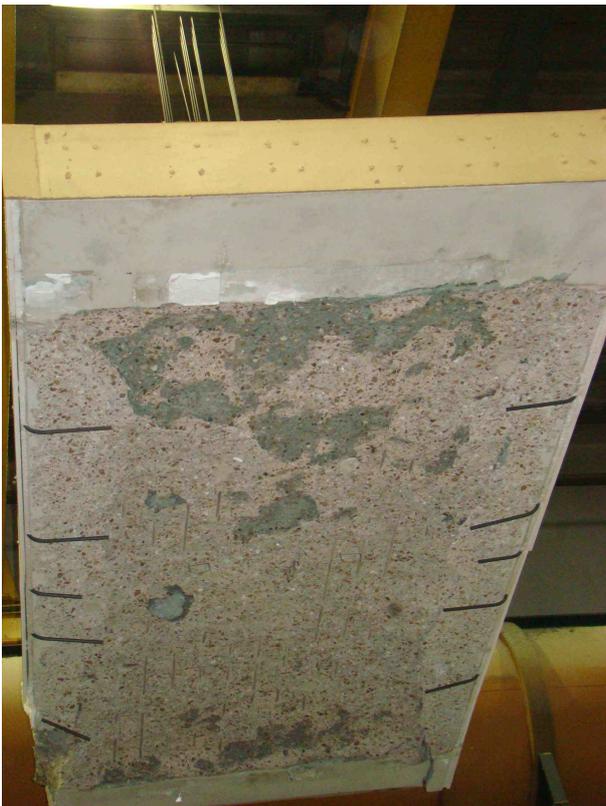
Figure 5. Test specimen 1 after the fire test

In the first test the bare concrete was directly subjected to the RWS fire curve. The test specimen started to spall almost immediately after the start of the test. The test was continued further irrespective of the intensity of spalling. Once the reinforcement was visible from the furnace camera (after 29 minutes), it was decided to stop the test for safety reasons. The temperatures on the concrete surface after a few minutes of spalling were almost following the furnace temperature, as can be seen in the final values of Table 2. In Figure 5, the test specimen after the fire test is shown.

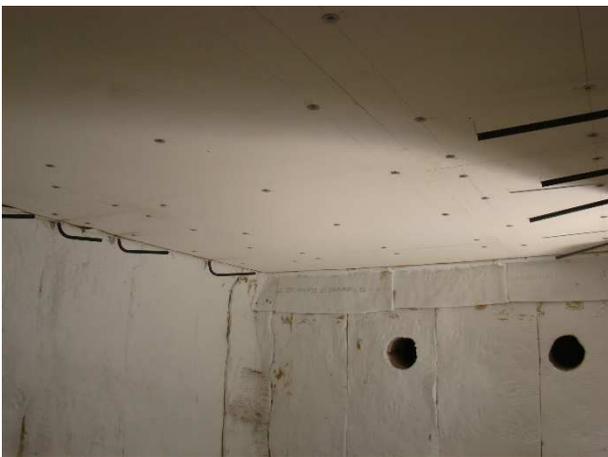
Figure 6. Test specimen 3 before the fire test

Passive fire protection boards which are fit for the tunnel hydrocarbon fire curve (RWS fire curve in this case) are used. The boards are post-fixed onto the concrete with the help of anchors, which makes

them easy to install. A typical board protection system is shown in Figure 6.
