Fire in the Heinenoordtunnel, Lessons learned.

René de Feijter¹, Remco van Werkhoven², Mark Goudzwaard³ & Ron Beij⁴

¹Efectis Netherlands BV, Bleiswijk, The Netherlands

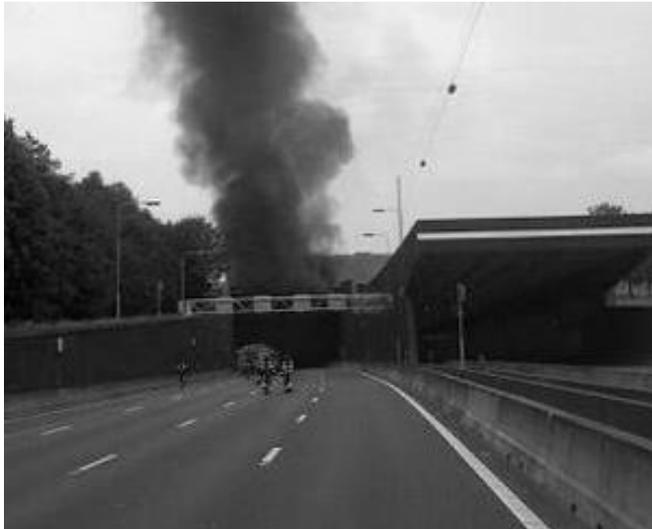
Figure 9 First arriving Fire truck.

The Traffic control centre has not communicated the right (escape)door number, related to the position of the burning truck, to the Fire Brigade. Some of the escape doors were jammed which made the search for the fire location and the position of potential victims on the downstream side of the fire difficult.

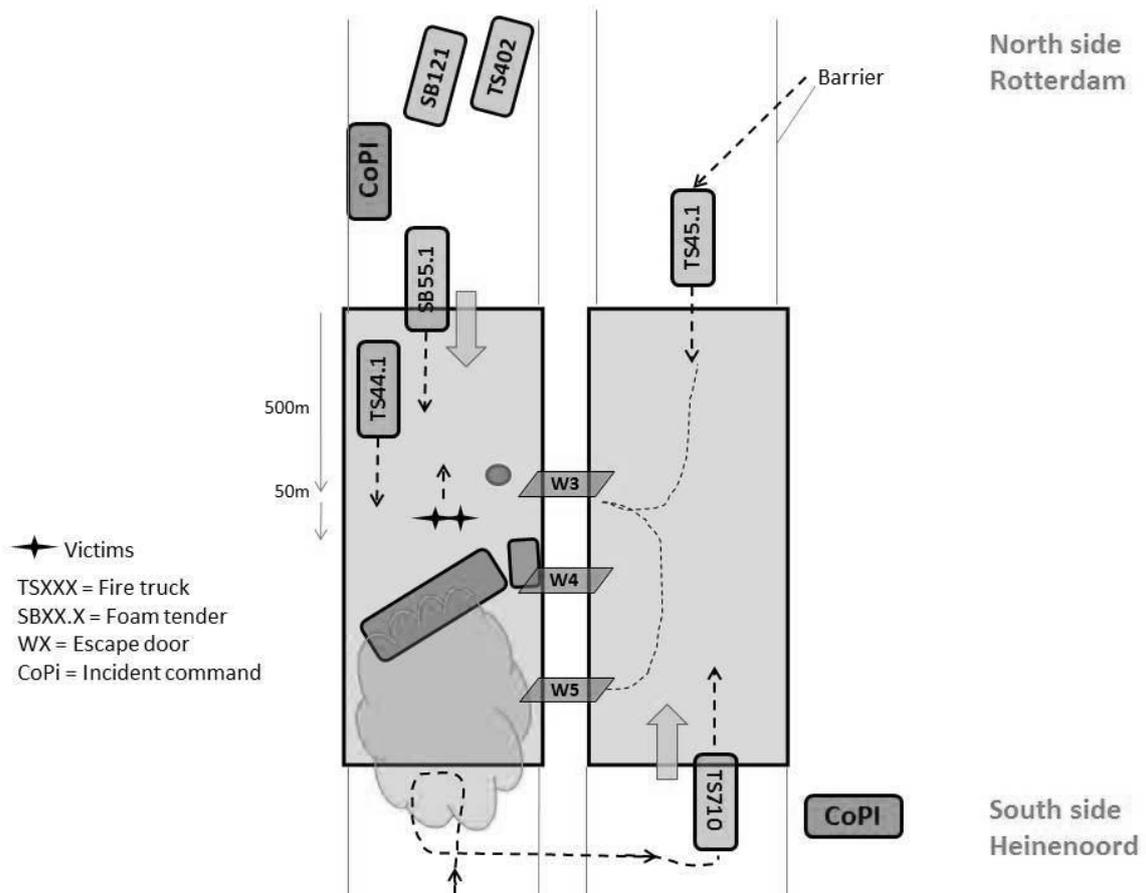
The second Fire truck (from Rotterdam-Rijnmond) arrived at the north side of the tunnel. They had to wait until the correct barriers at the side of the road were opened before they could enter the tunnel trace. This took some time and because of that the third unit (from the Rotterdam fire department) arriving at the fire from the north side, was the first unit who could actually see the fire. This unit was not in (radio)contact with the unit from Zuid-Holland Zuid. Because they were going for an incident with a potential for a lot of victims (a bus fire in a tunnel), they went (not conform procedure) into the tunnel tube with the burning truck and discovered the two victims from the car involved in the crash. The victims were able to escape their car by them self. The fire was first attacked using a hoseline from a tunnel emergency unit. Because of a malfunction in this unit a foam tender was called to fight the fire in the tunnel.

Figure 10 Overview of fire fighting operations.

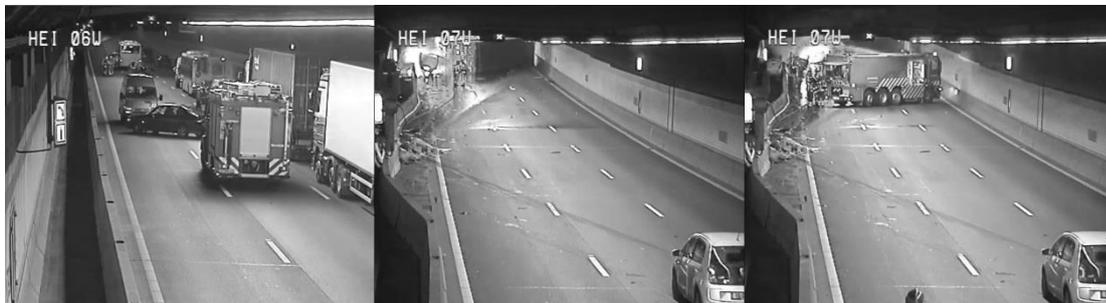
Figure 11 Fire Fighting operations.
